Walk Around

TBF/TBM Avenger

Walk Around Number 25
squadron/signal publications

By Lou Drendel

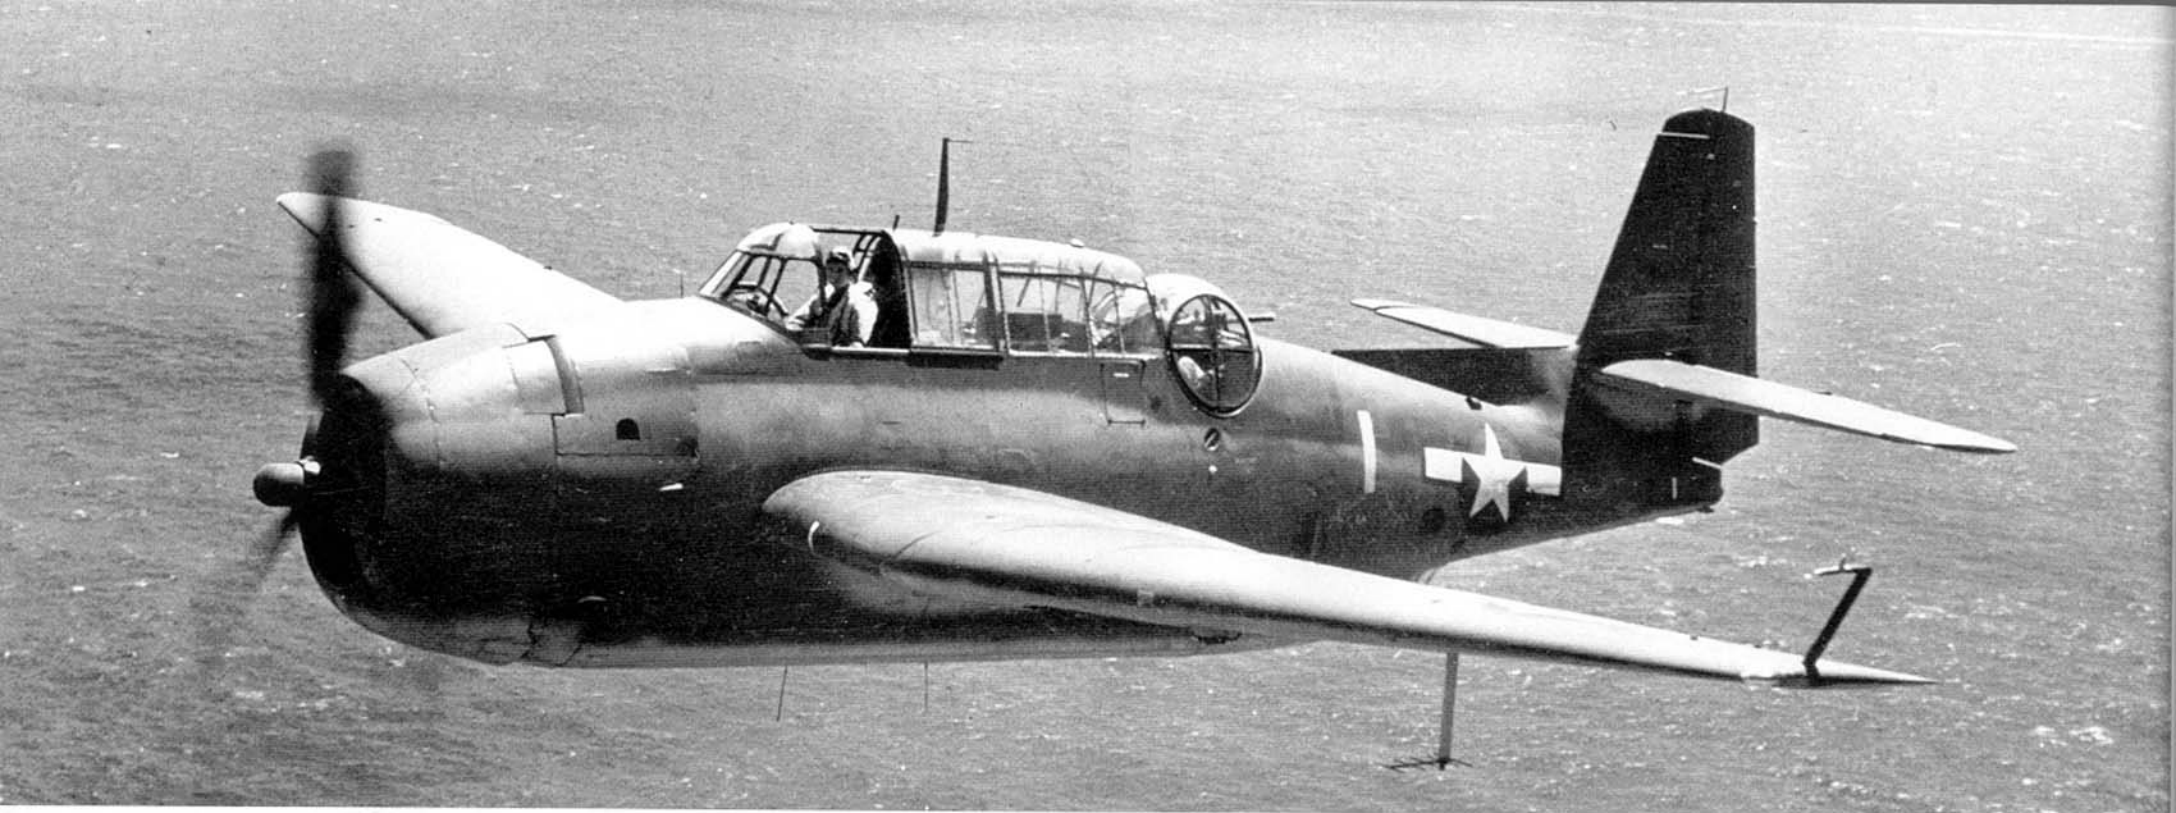
A TBF-1 from an unidentified unit flies on patrol over the Pacific during 1944. This Avenger is equipped with the Westinghouse Air-to-Surface Type B (ASB) radar with Yagi antennas under each wing. The Yagi antenna was mounted 40° outboard, with the array of dipoles able to rotate slightly port or starboard as required. The bombardier viewed the radar

returns on his radarscope, located at his aft fuselage station. ASB radar – fitted to most production TBFs and TBMs – allowed Avenger crews to attack surface targets at night and under most weather conditions. The pitot tube was mounted on an inverted L-shaped fairing placed on the upper port wing tip. (Norman E. Taylor Collection)

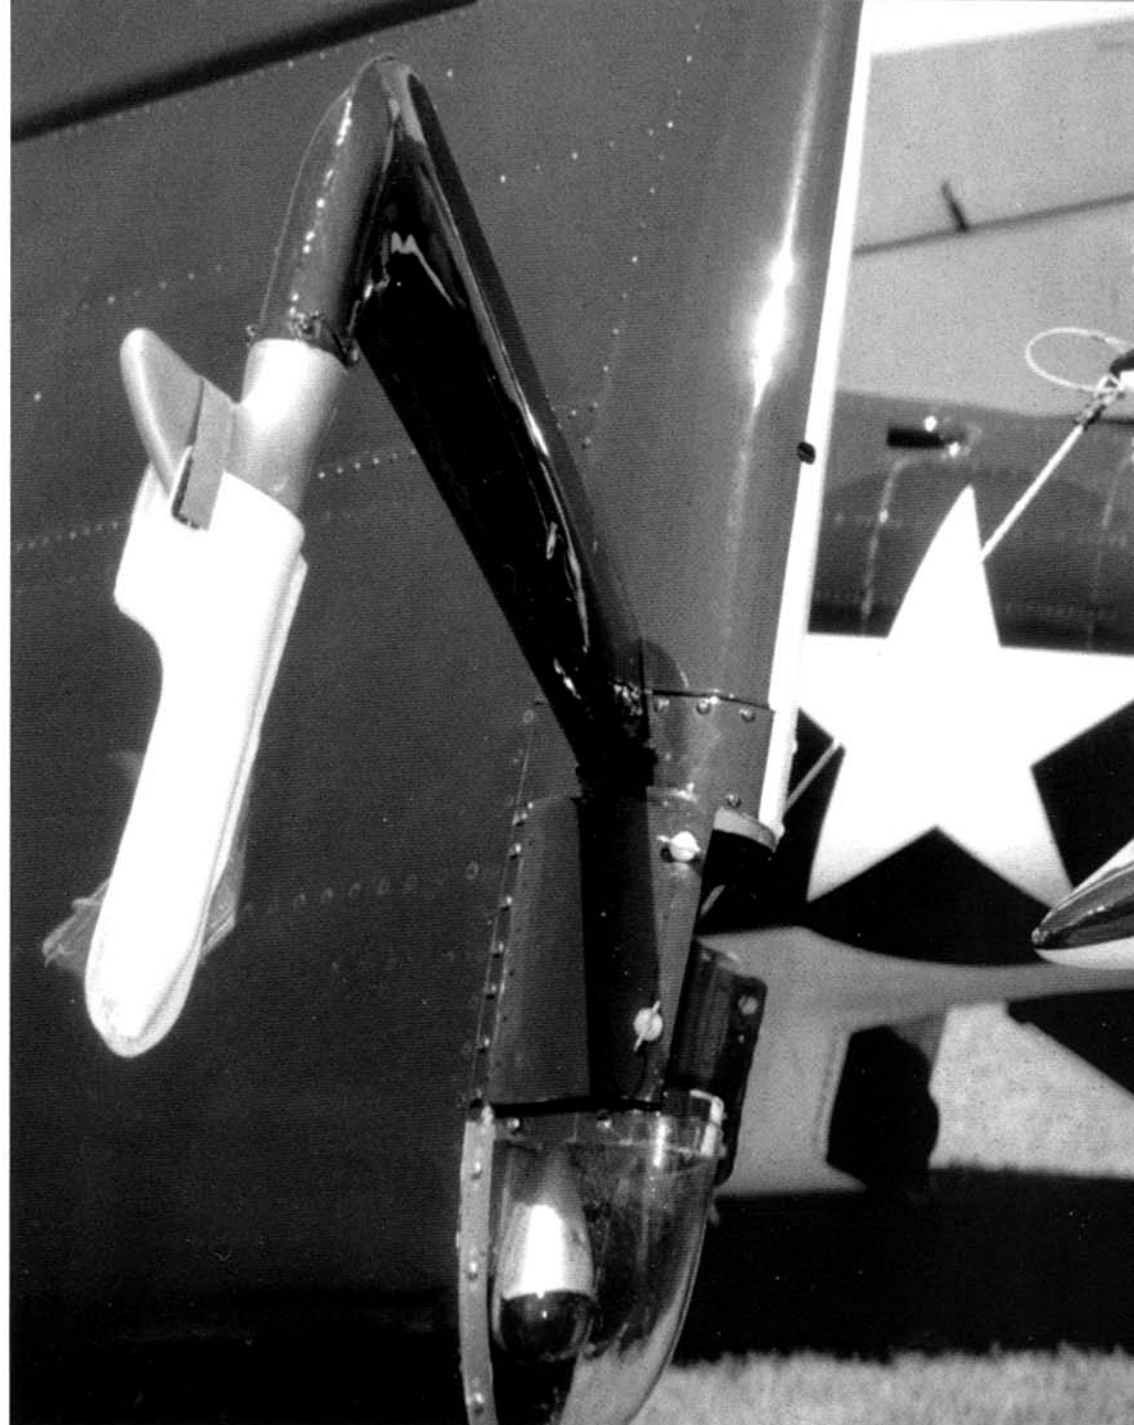
The cover placed on this pitot tube protected it on the ground from insects, which were prone to building nests inside the tube's opening. This cover was clipped over the upper portion of the tube head and was removed before flight. The wing tie-back cable was secured to the leading edge of the Avenger's horizontal stabilizer. This cable ensured that the aircraft's wings would remain fully folded back under high wind conditions. (Lou Drendel)

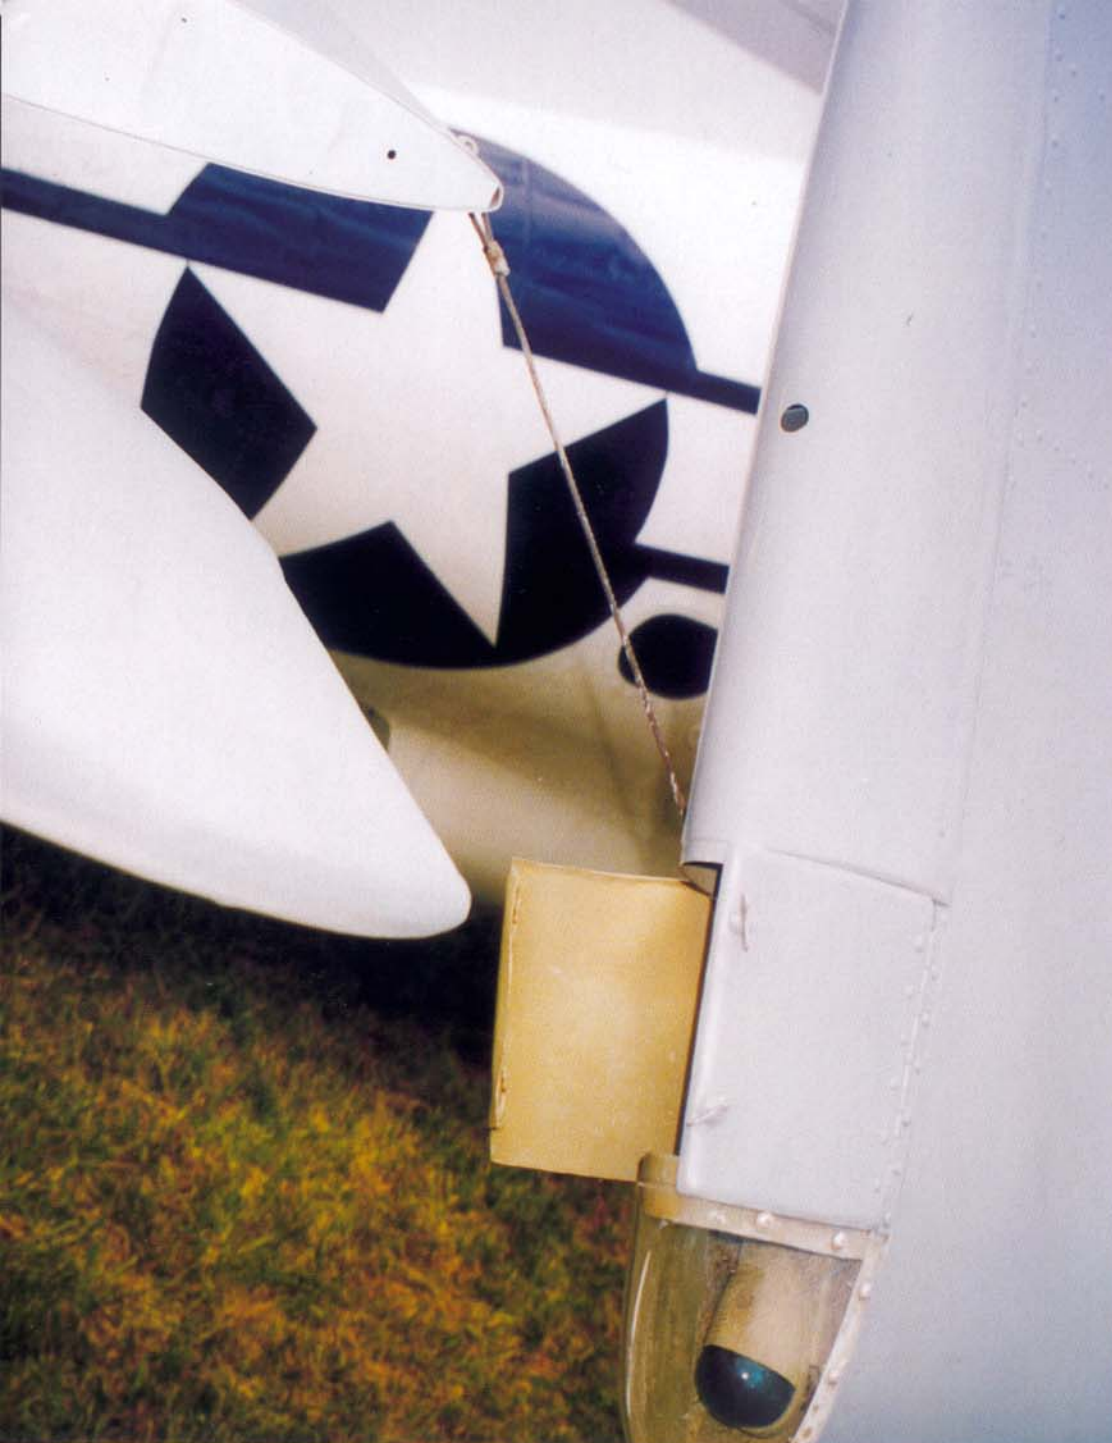
The wing tie-back cable enclosure consisted of upper and lower doors, which conformed to the wingtip's shape and size. These doors were secured with Dzus fasteners – countersunk screws with slotted shanks used to close removable or hinged panels – when the cable was not in use. The tie-back enclosure and door inner surfaces were painted Interior Green (FS34151). (Lou Drendel)

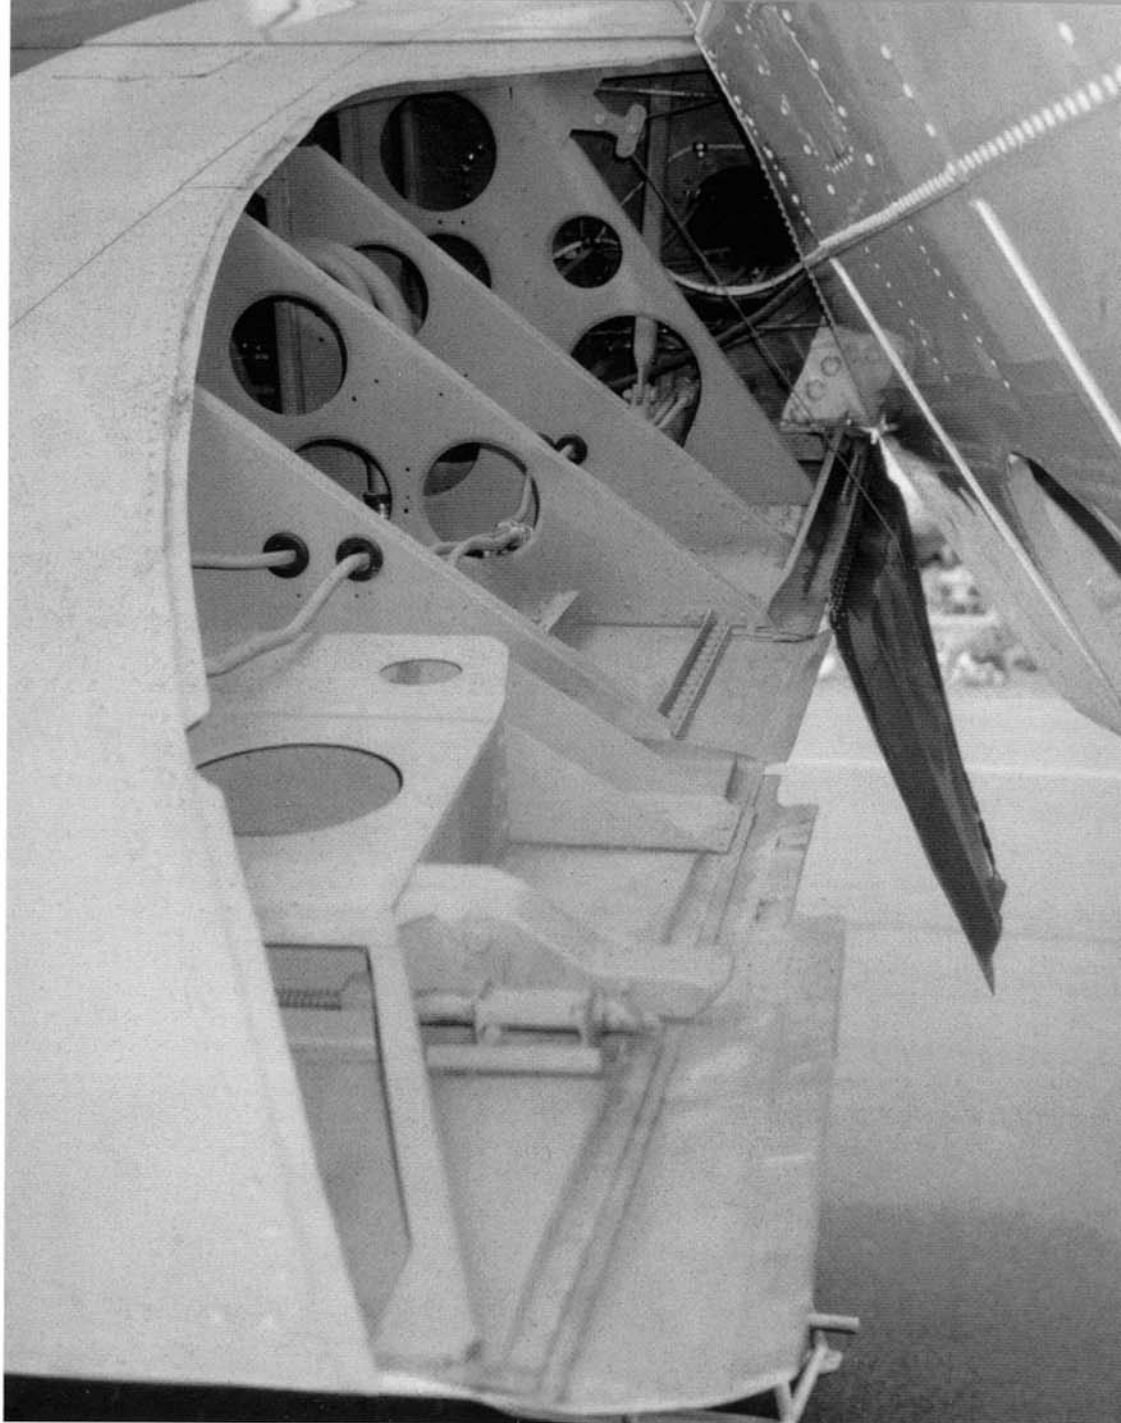
When the Avenger's outer wings were folded back, a portion of the inner wing uppersurface was exposed. The triangular sections inside the wing were stringers used to provide strength to this area of the airframe. All wing inner surfaces were painted with anti-corrosion Zinc Chromate (FS34227) paint. The lowered triangular door covered the cutout portion of the outer wing panel and automatically opened when the wing was folded. (Lou Drendel)

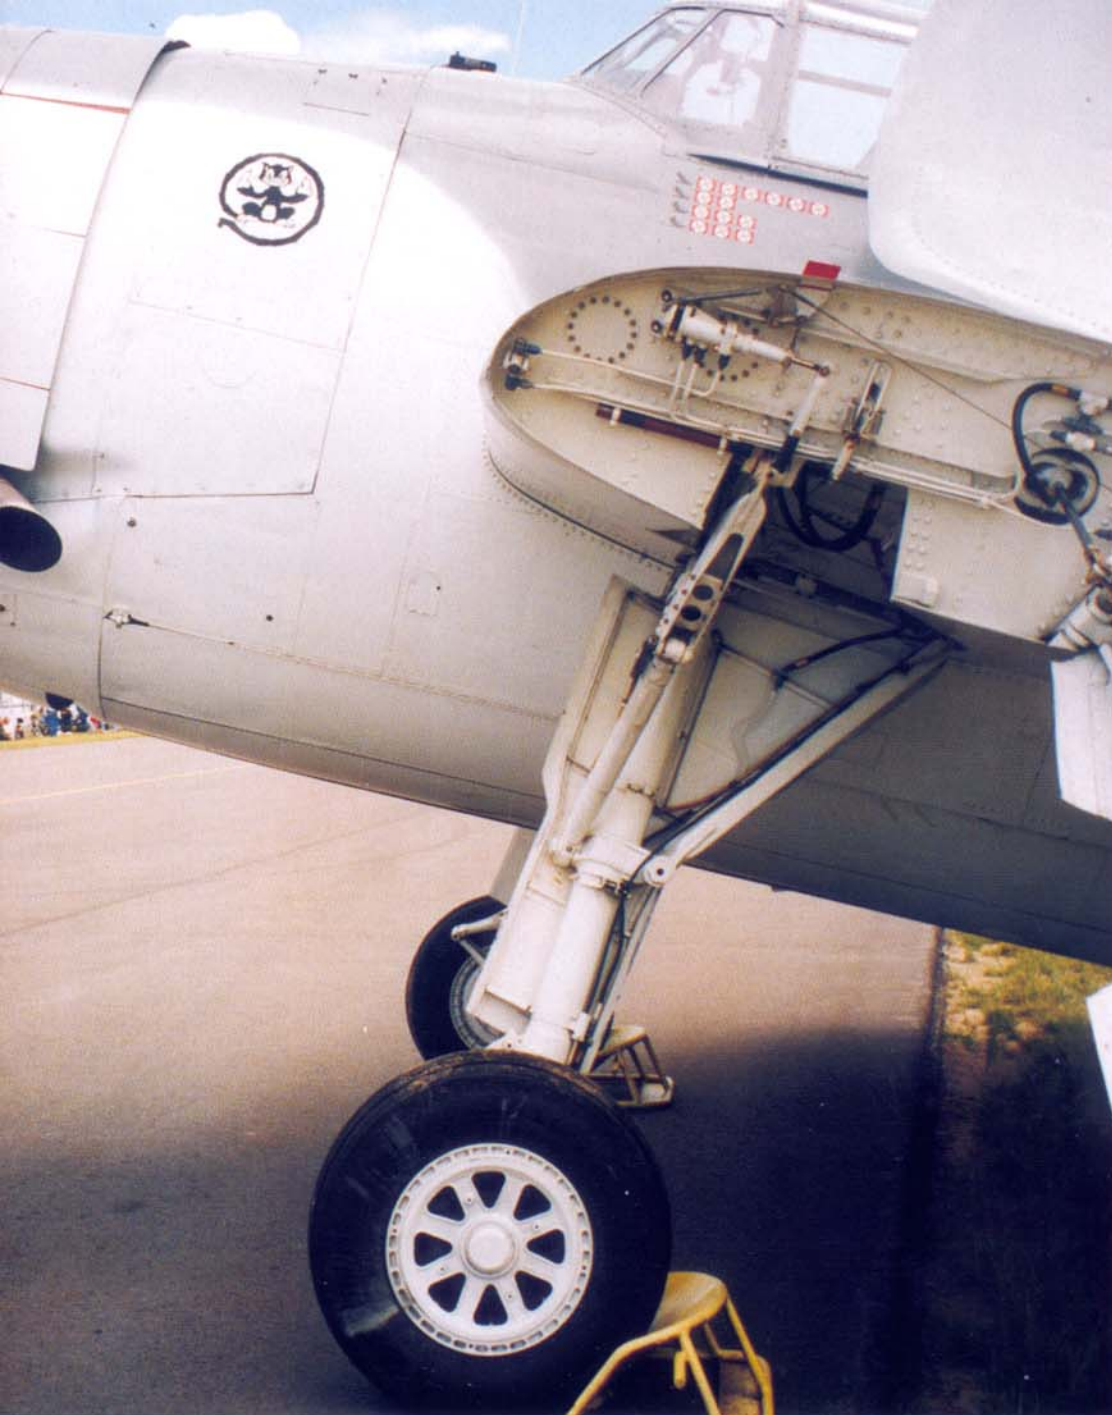
The main landing gear for all Avenger models operated hydraulically. This unit retracted outward and upward into the wheel wells located in the outboard wing panels. The gear retraction strut was mounted to the forward gear leg and the landing gear bay. Hydraulic pressure on this strut pulled up the landing gear leg on retraction and lowered the gear leg on extension. (Lou Drendel)

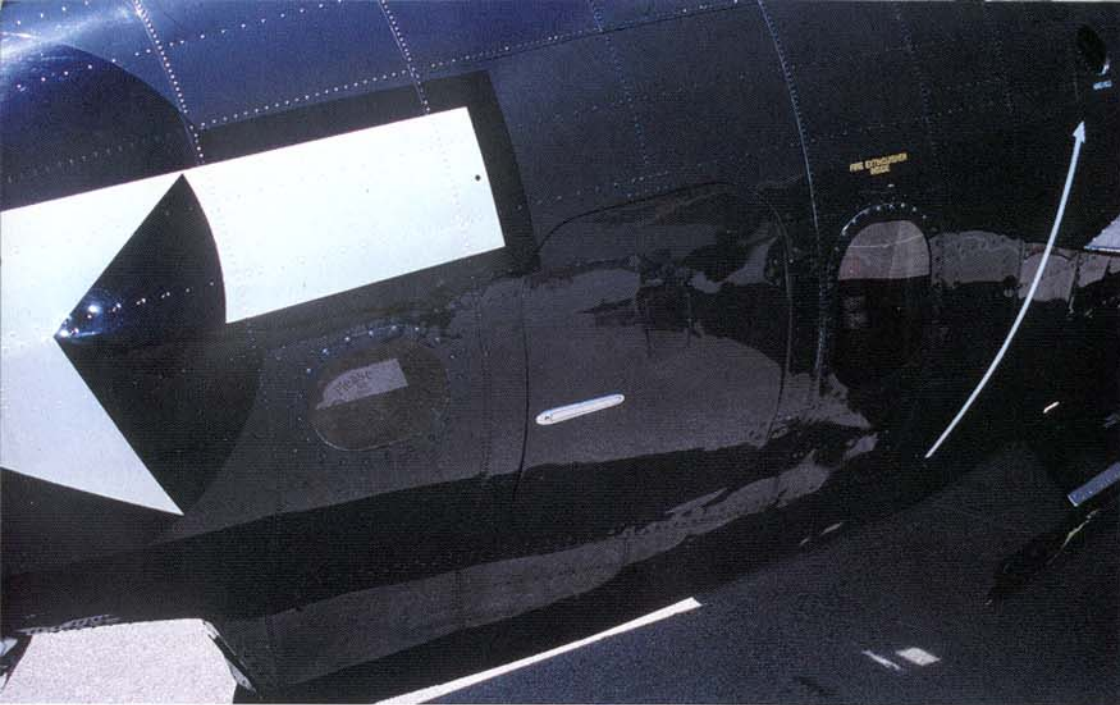
Two oval windows flank the turret gunner and radio operator/bombardier's access hatch on the Avenger's starboard rear fuselage. Identical windows were placed on the port rear fuselage. This window arrangement was standardized on late production TBF-1s and continued through the TBM-3. Avengers supplied to Britain during World War II replaced the windows nearest the wing with observation domes. (Lou Drendel)

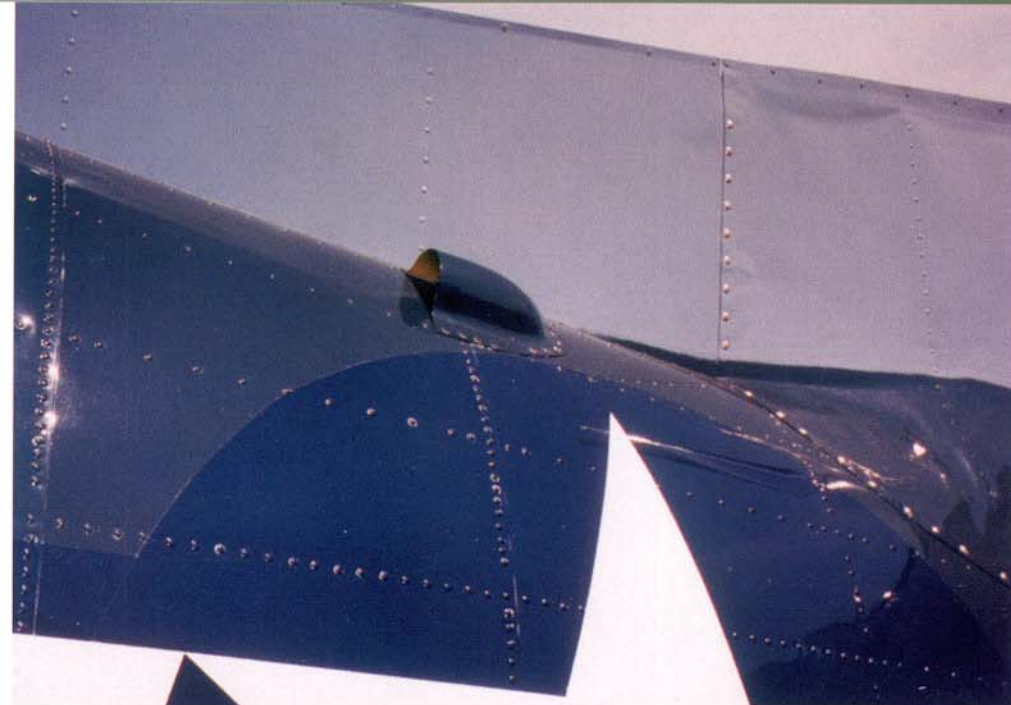
An air intake scoop was placed on the upper aft fuselage of all TBFs and TBMs, immediately port of the dorsal fin. This scoop brought fresh air into the Avenger's aft compartment. The dorsal fin aided in the aircraft's directional stability and was added to the Avenger beginning with the second XTBF-1 prototype. (Lou Drendel)

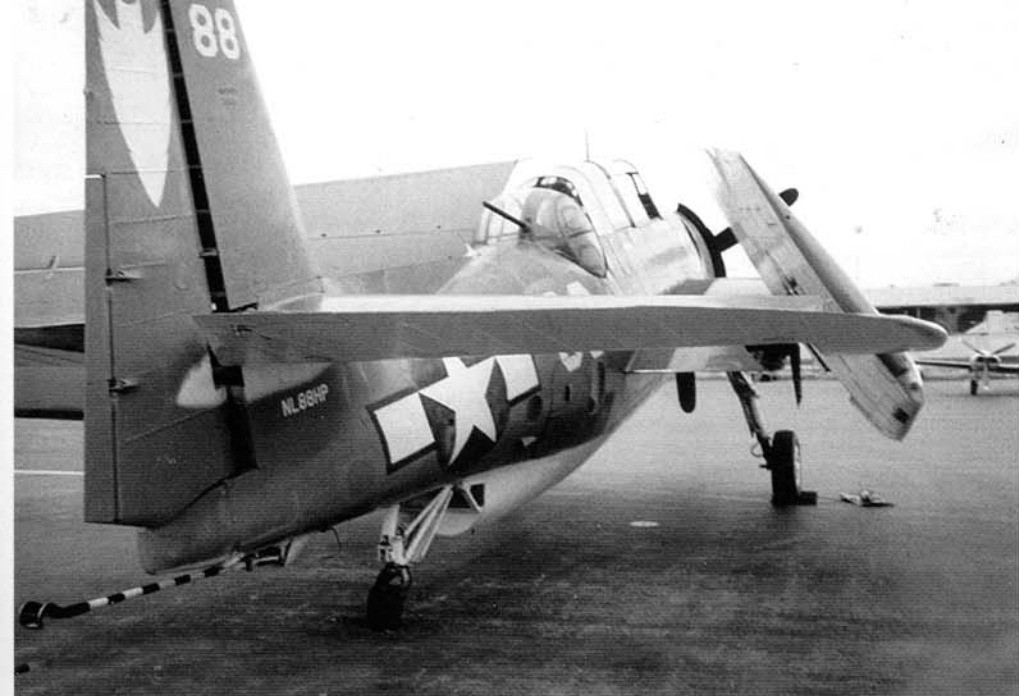
This restored TBM-3E (NL88HP) features the externally mounted arresting hook fitted to late production examples of this model. This hook replaced the retractable arresting hook found on earlier Avengers. The wings were folded and the wingtip tie-back cables fastened to the horizontal stabilizers. The large rudder servo and trim tabs were used to offset control pressures encountered in overcoming propeller torque at low speeds. (Walt Houghton)

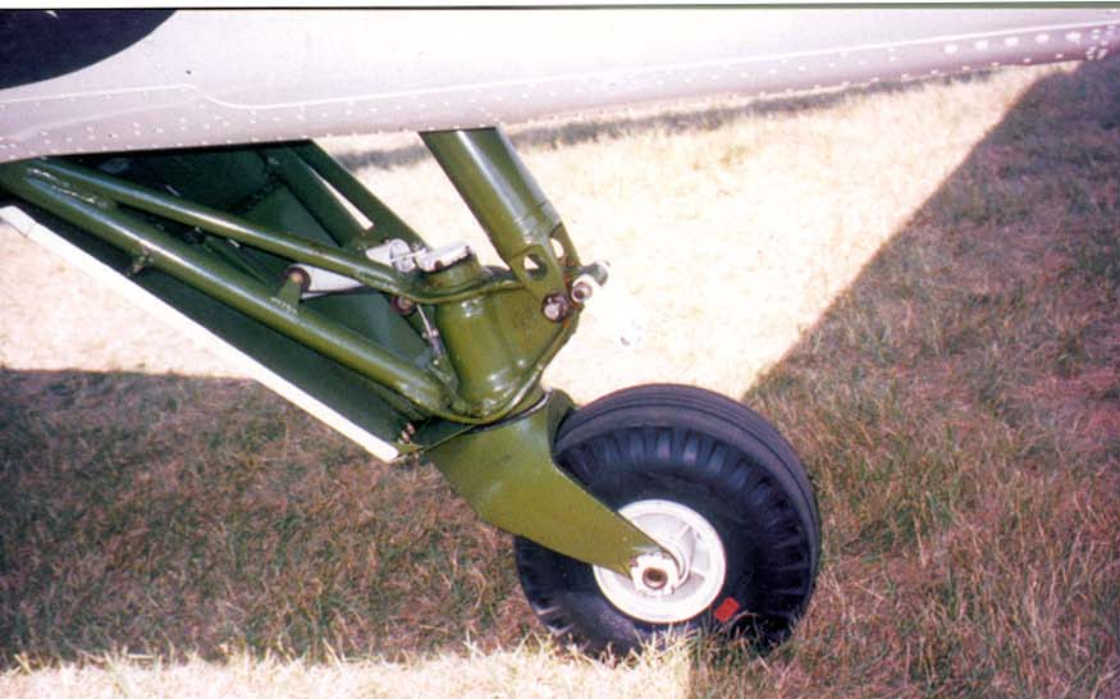
The TBM tail landing gear consisted of a self-aligning, full swivel type tail wheel with a controllable non-swivel lock mechanism, a Bendix Pneudraulic (pneumatic and hydraulic) shock strut, and a tire and wheel assembly. The white bracket above the tire was the fitting for the hold back cable used when catapulting the Avenger from a carrier. The landing gear strut and door inner surface – finished Bronze Green on this example – was painted on service aircraft to match the Avenger's undersurface color. (Lou Drendel)

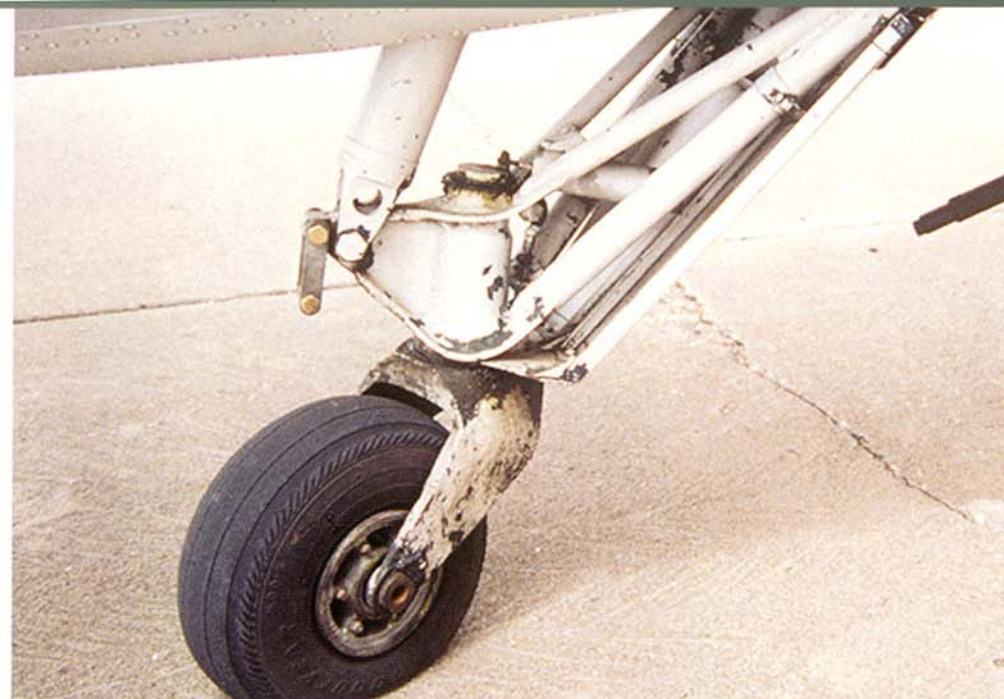
The tail landing gear included a two-pronged drag strut mounted beside the gear door, with a centering unit placed above the drag strut. These struts and the Bendix shock strut mounted aft were connected to the castor assembly in which the tail wheel was mounted. The shock strut pulls the tail landing gear fully up into the aft fuselage on retraction. The tail gear door covered only the landing gear strut, not the tail wheel. (Glen Phillips)

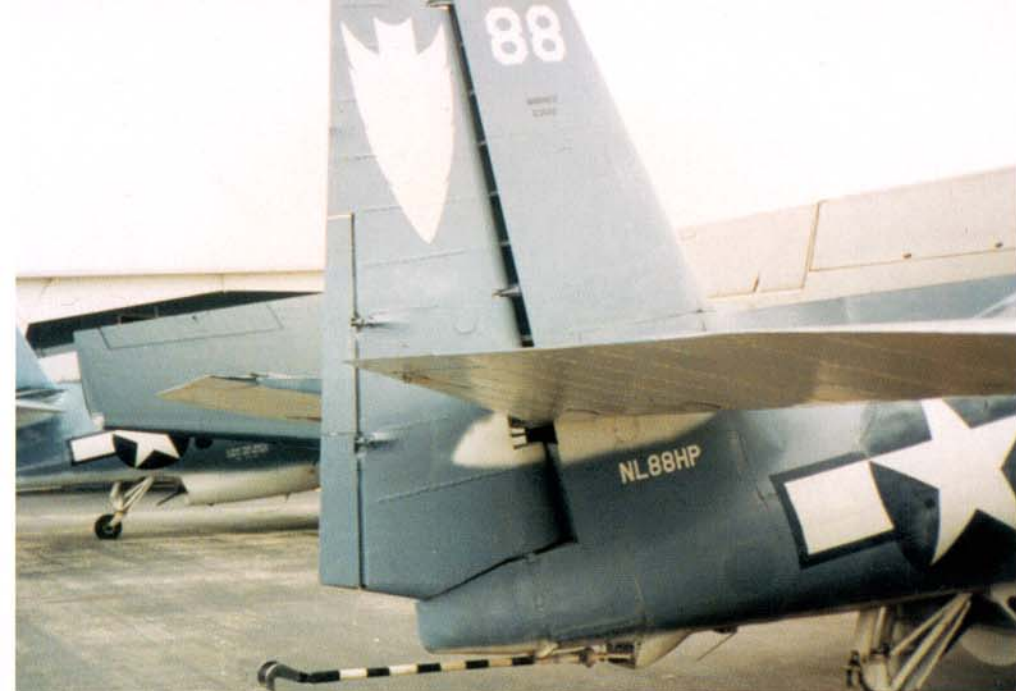
This restored TBM-3E (BuNo 53522, NL88HP) displays a white arrowhead on the rudder. This insignia was applied to Avengers assigned to Composite Squadron 8 (VC-8) aboard the USS NEHENTA BAY (CVE-74) in early 1945. The Avenger and most other World War II-era aircraft had fabric rudders, elevators, and ailerons. The TBM's rudder had a range of 24° to either port or starboard. The white area under the horizontal stabilizer's base provided counter shading as part of the camouflage scheme. (Walt Houghton)

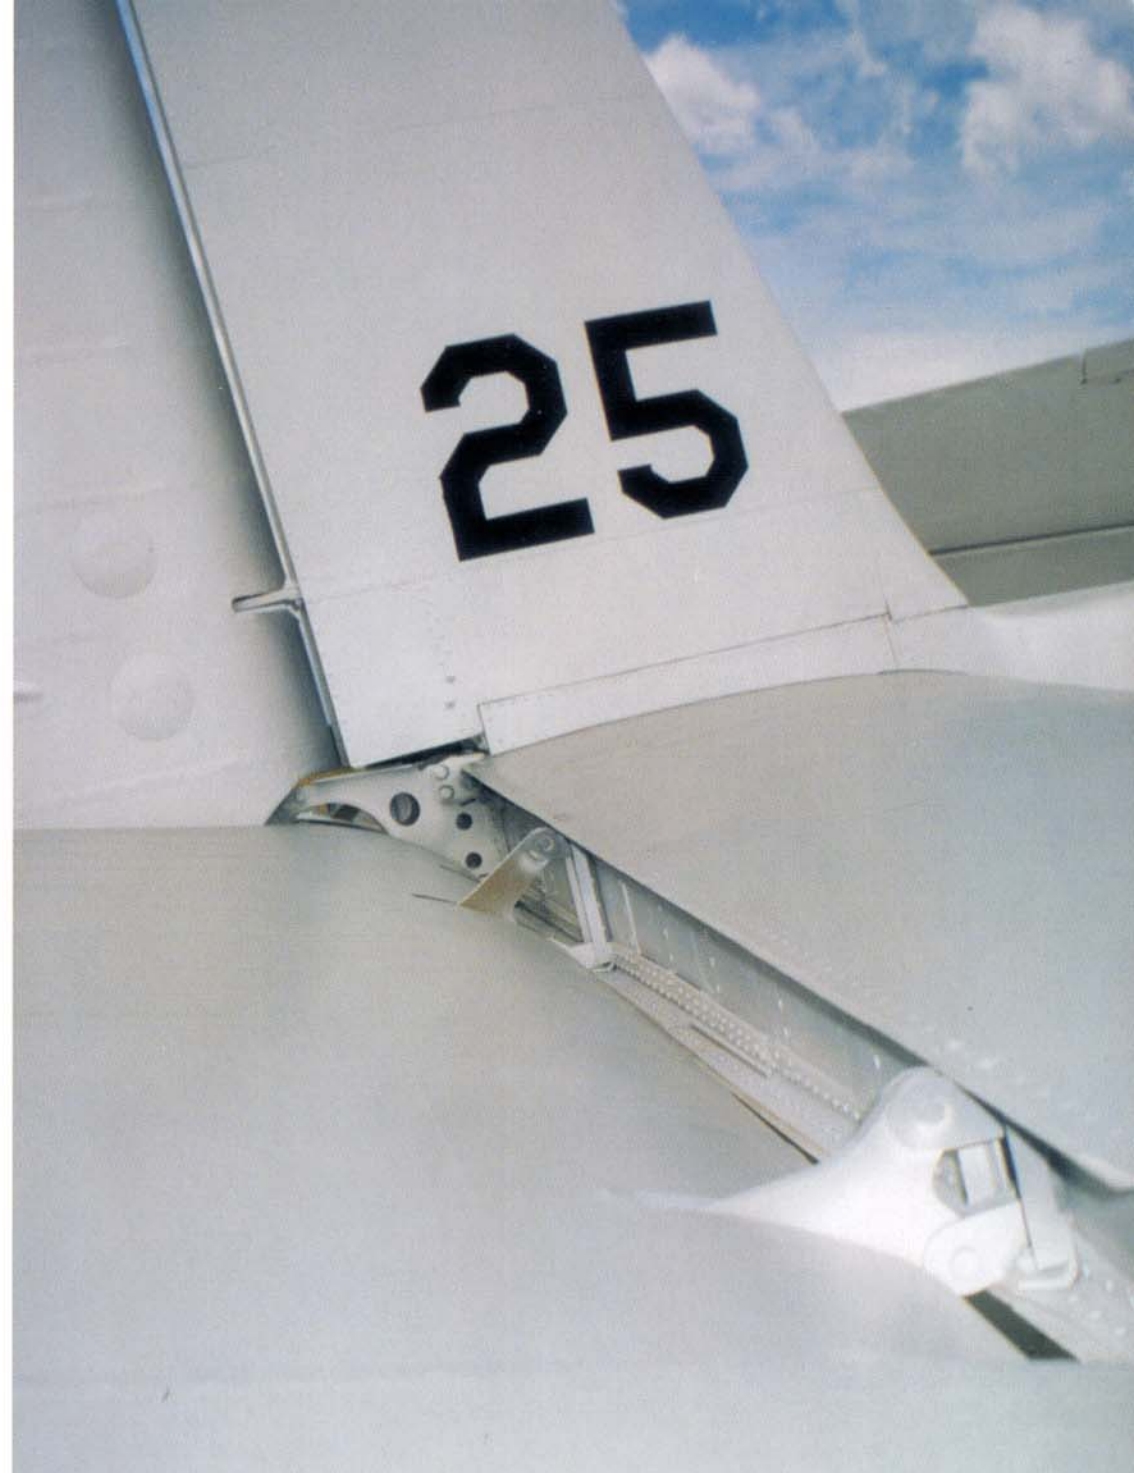
Each elevator was fitted with two hinges mounted on the elevator spar. These hinges were attached to the elevator spar and rotated on brackets fitted to the horizontal stabilizer. The elevator control unit was placed between the horizontal stabilizers' root. The horizontal stabilizer skins were aluminum alloy, while the elevator was fabric covered. (Lou Drendel)

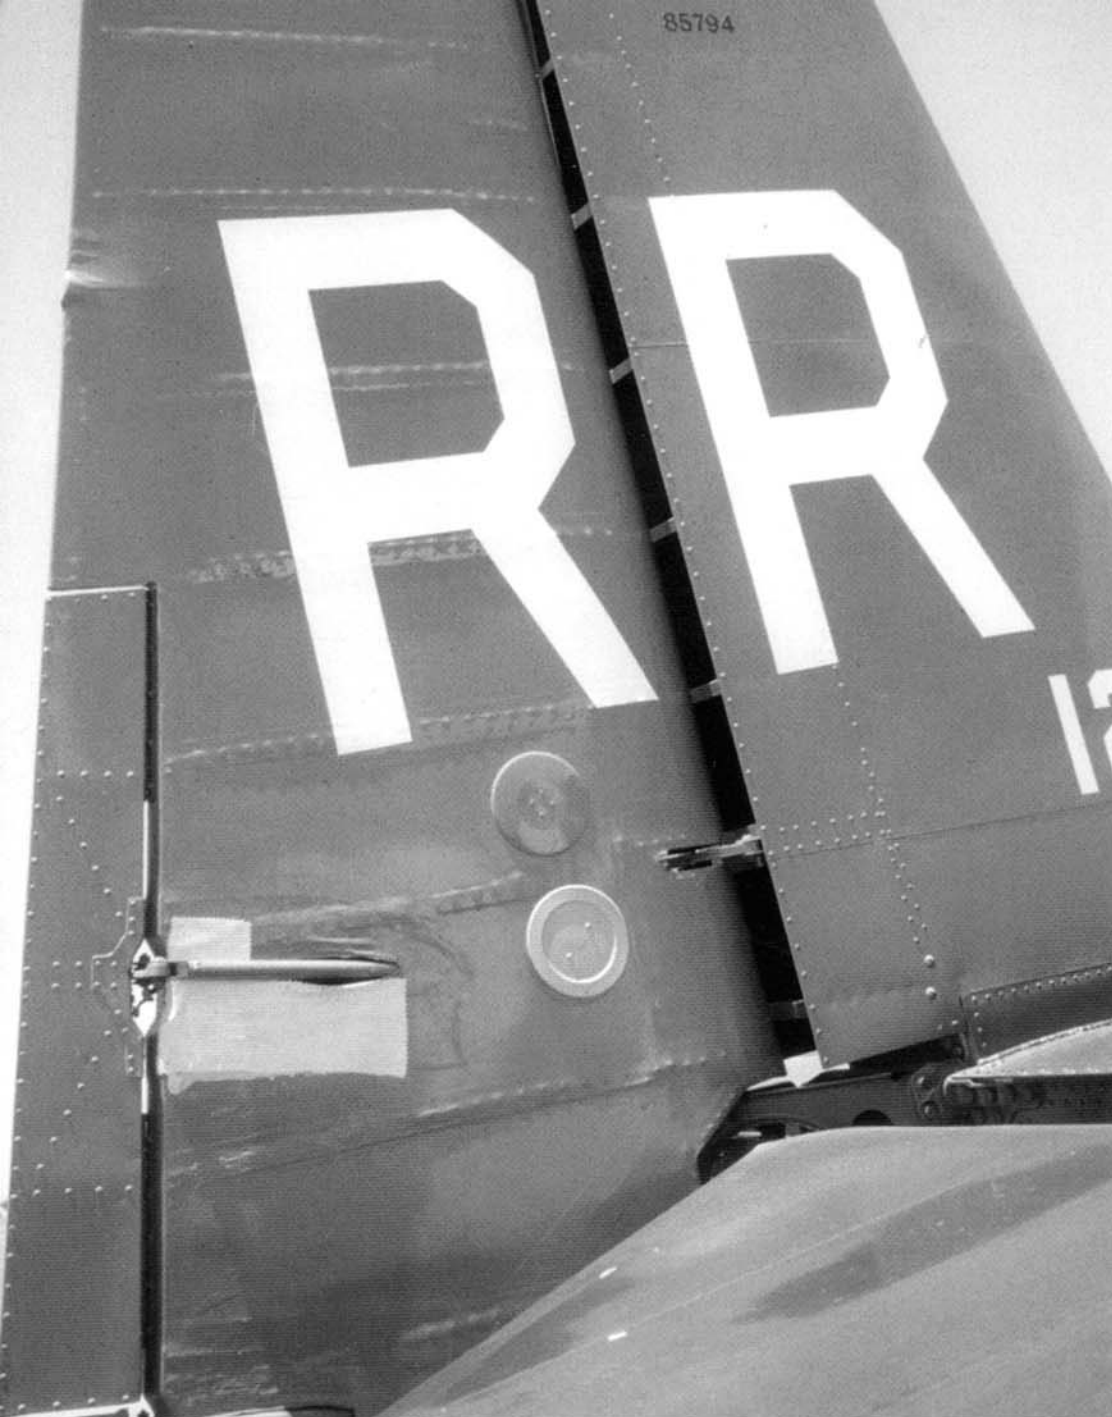
One of the advantages of fabric covered control surfaces is the ability to repair holes with duct tape! The tape repaired a hole immediately under the rudder servo tab horn. This horn and the horn for the trim tab immediately below were only on the rudder's starboard side. Control horns provided aerodynamic force to aid in the deflection of the tabs. This aircraft is the combat veteran TBM-3E (RR-125, BuNo 85794), owned by Coke Stuart. (Lou Drendel)

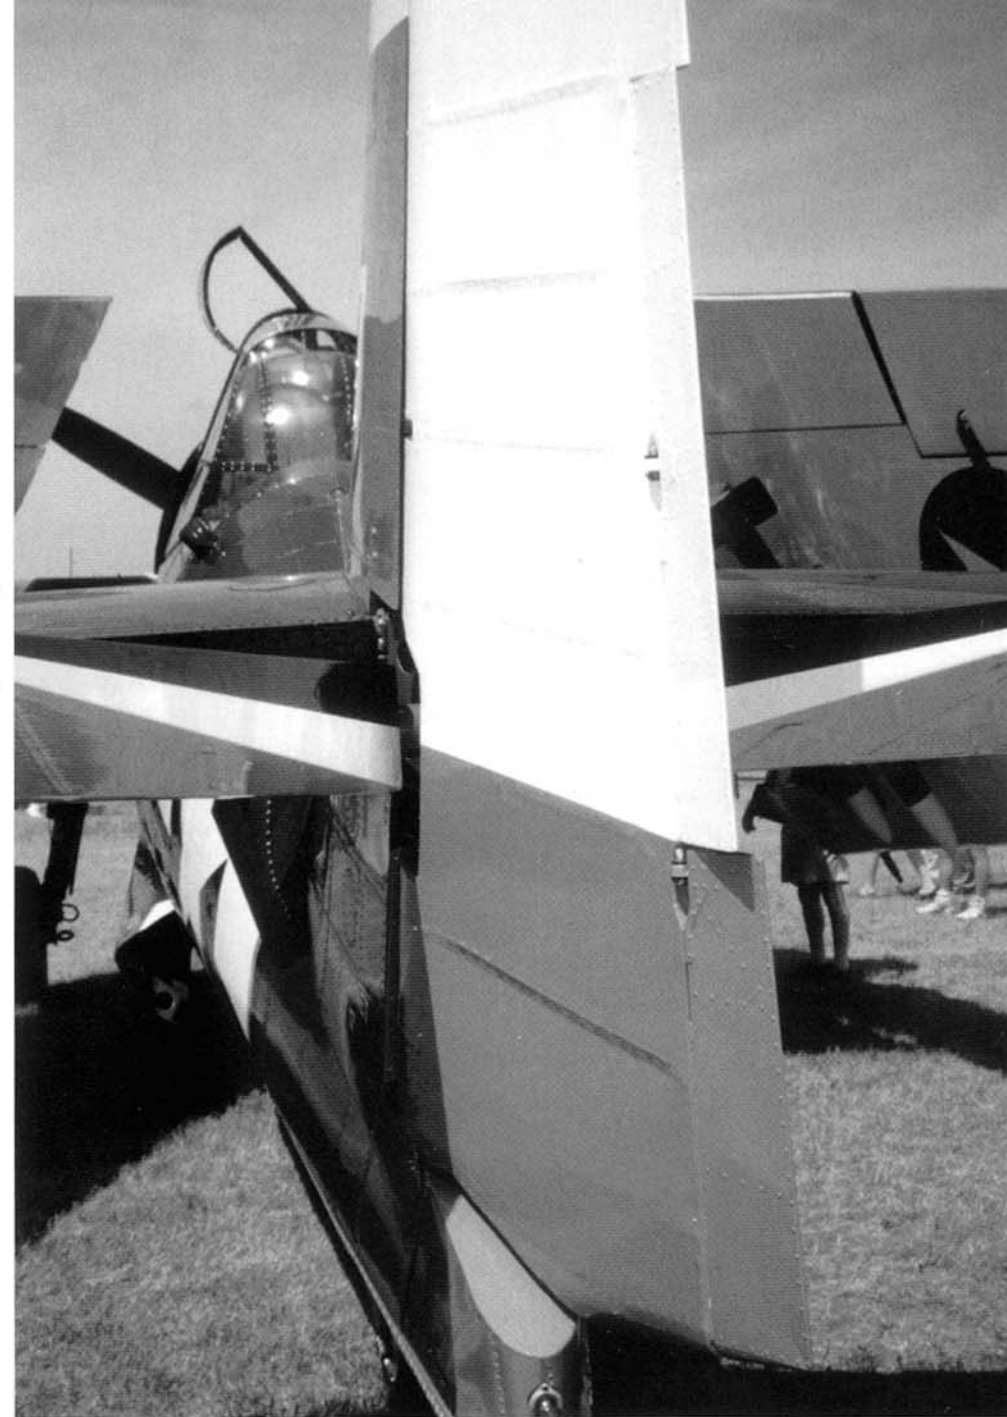
Avengers were equipped with aluminum split rudder tabs. The servo tab at the top generated the aerodynamic force required for moving the rudder port or starboard. The trim tab immediately below the servo tab was used to counteract aerodynamic forces. This trim tab moved opposite the direction of rudder deflection and served to 'boost' the rudder, easing its use for the pilot. (Lou Drendel)
